**A STUDY OF TRAIL DEGRADATION
ALONG THE PAT SIN RANGE,
NORTH NEW TERRITORIES, HONG KONG**

Thesis submitted to the Graduate School
of the Chinese University of Hong Kong
in partial fulfilment of the requirements
for the degree of Master of Philosophy

June, 1992

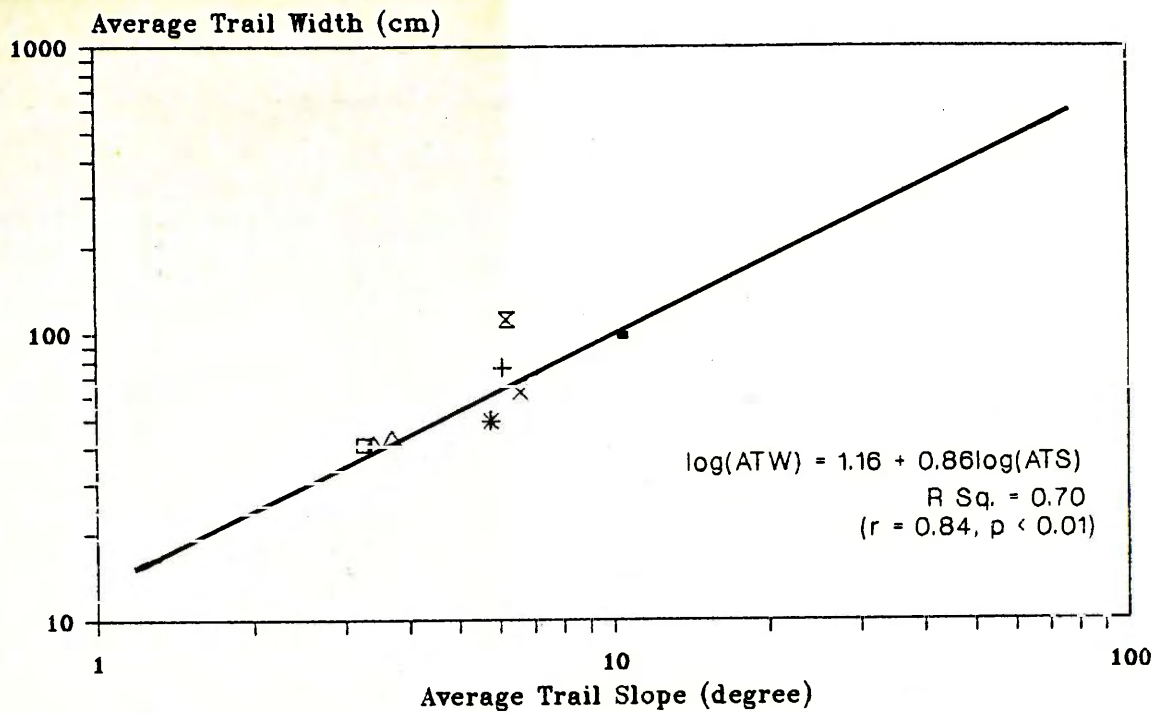
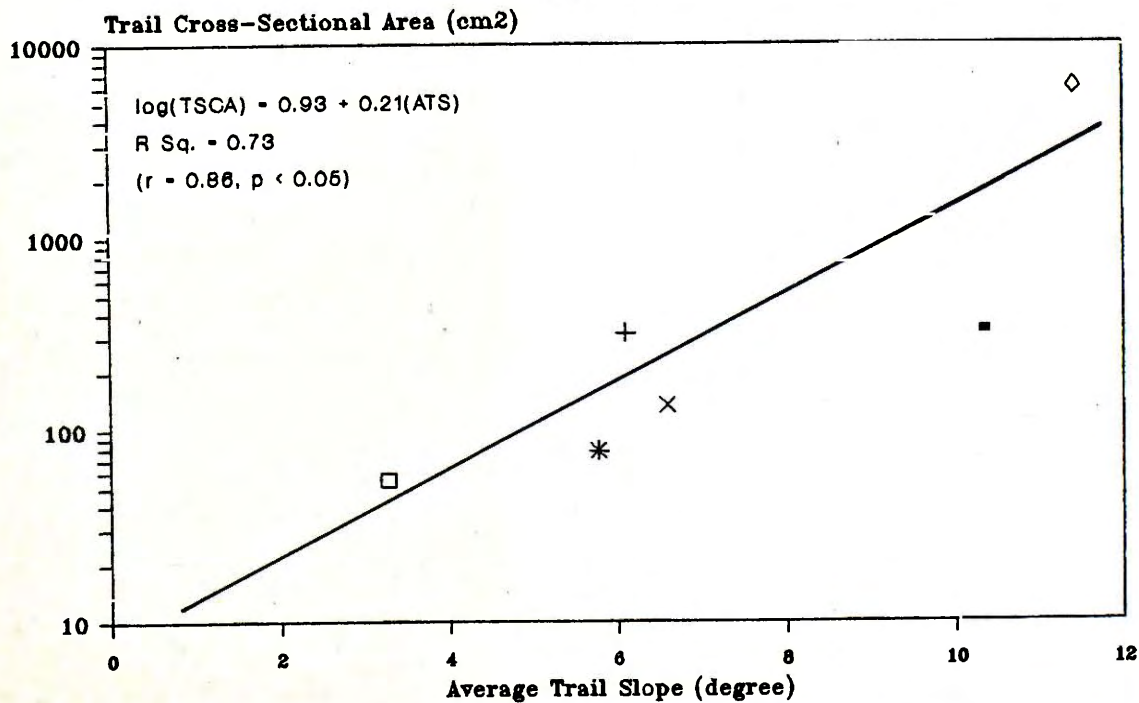
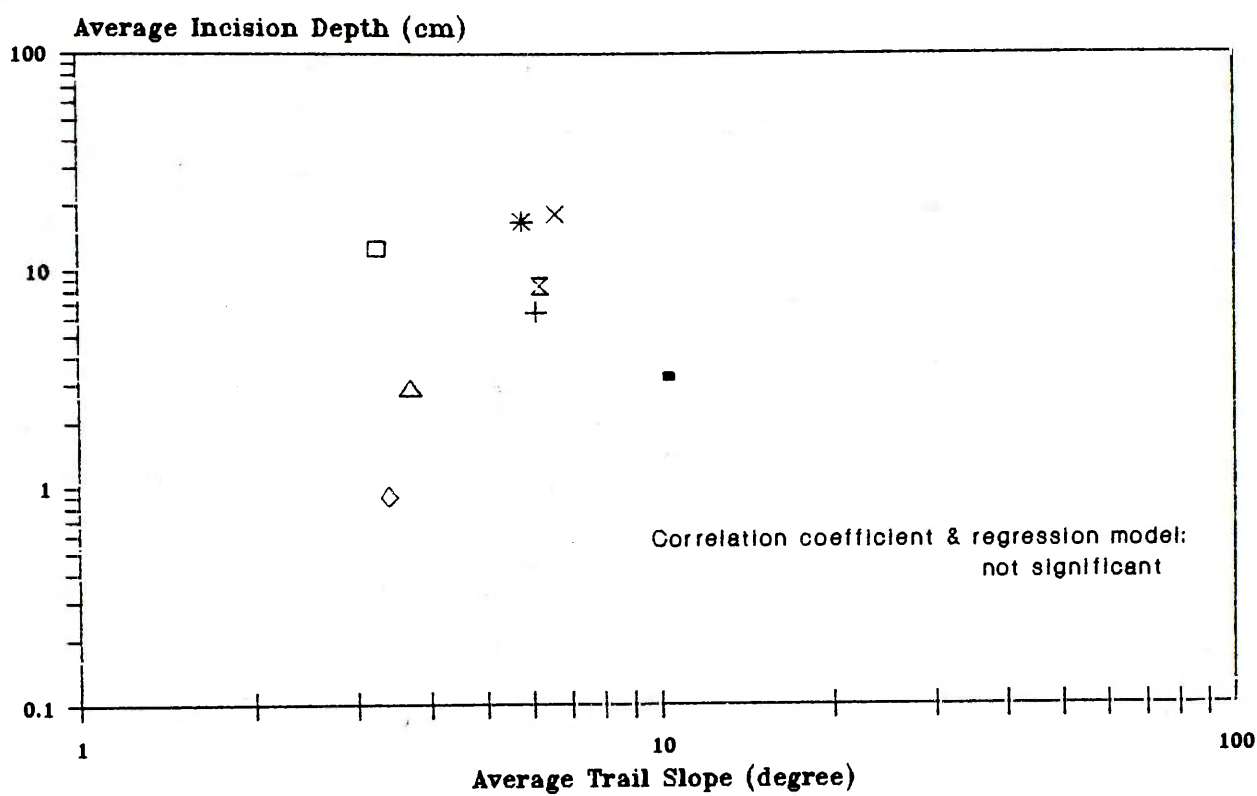
(a) Trail Slope and Width

(b) Trail Slope and Cross-Sectional Area

(c) Trail Slope and Incision

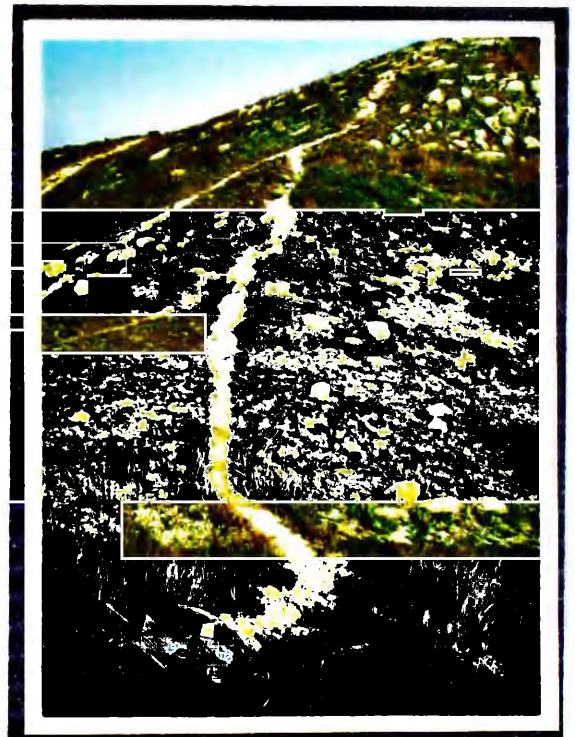
Location: Ping Fung Shan
Rock: Sedimentary
Position: OB-Sidehill
Trail Slope: 5.39°
Major Problems:
 (1) deep incision - 15cm
 (2) soil loss - 1049cm^2
Probable Cause:
 Near trail junction
Management Recommendation:
 (1) Level tread
 (2) harden backslope

Level tread and place water bar

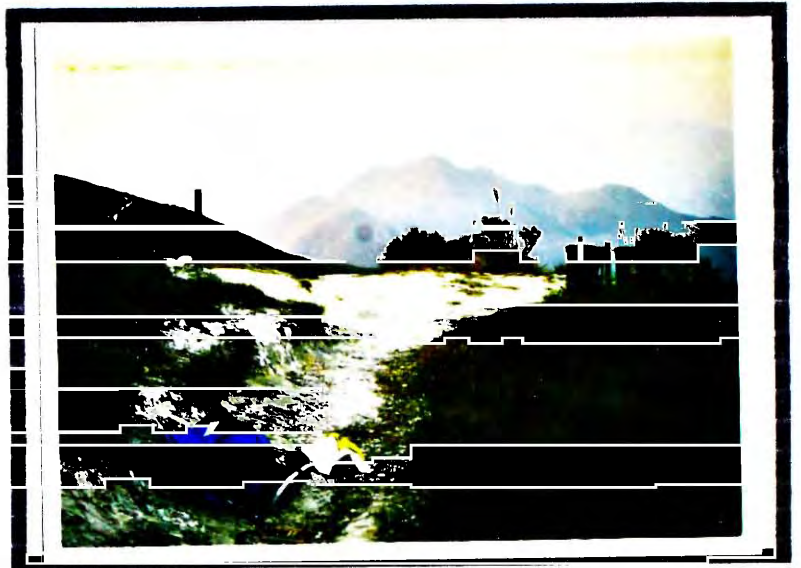
Location: Near Wong Leng
Rock: Sedimentary
Position: LV-Valley Floor
Trail Slope: 8.61°
Major Problems:
 (1) wide tread - 228cm
 (2) multiple treads
Probable Cause:
 Switchback
Management Recommendation:
 Education/Interpretation

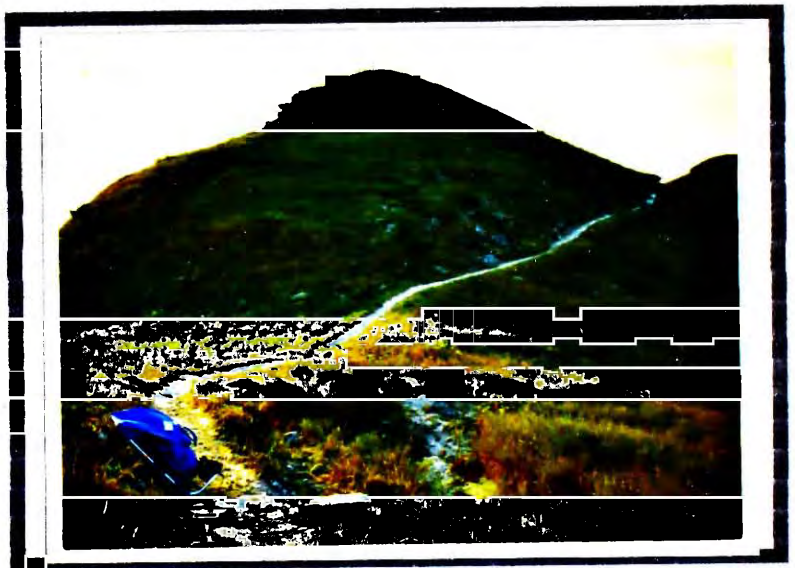
Location: Wong Leng
Rock: Sedimentary
Position: OB-Sidehill
Trail Slope: 6.83°
Major Problems:
 (1) deep incision - 20cm
 (2) too narrow tread - 51cm
Probable Cause:
 Steep sideslope
Management Recommendation:
 fill incised tread

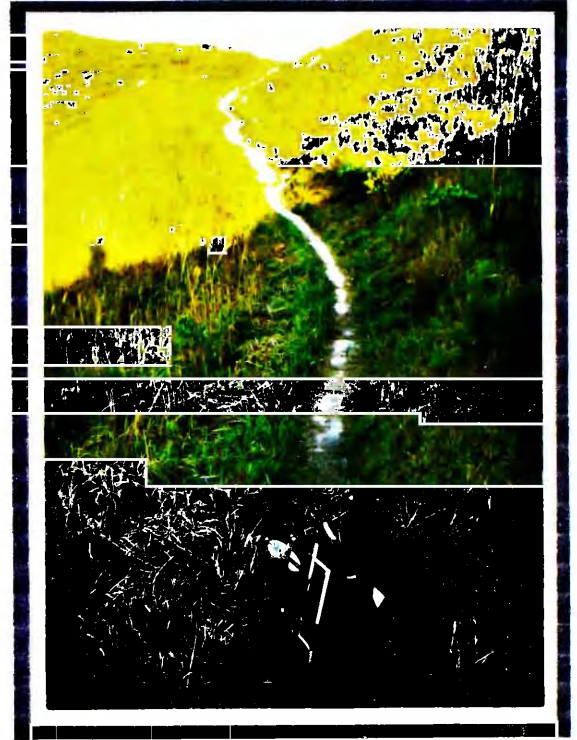
Location: Ping Fung Shan
Rock: Sedimentary
Position: DA-Interfluve
Trail Slope: 8.89°
Major Problems:
 multiple treading
Probable Causes:
 (1) sightseeing at both sides
 (2) gentle sideslopes
Management Recommendation:
 Education/Interpretation
